Summary Report for Sarasota Bay

Seagrass Integrated Mapping and Monitoring Program

Mapping and Monitoring Report No. 2.0

FWRI Technical Report TR-17, version 2.0

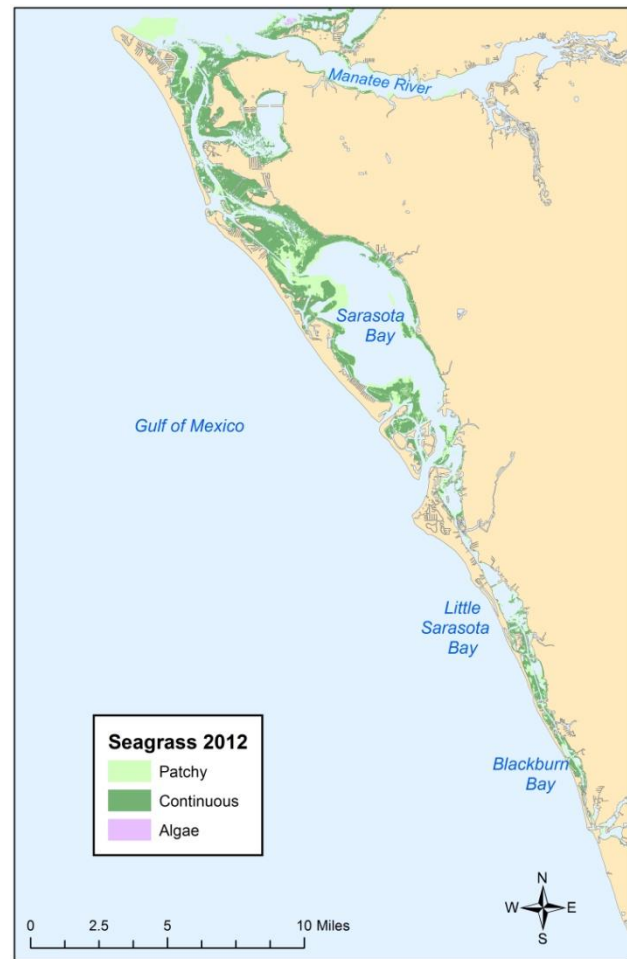
Figure 1 Seagrasses in Sarasota Bay, Little Sarasota Bay, and Blackburn Bay, 2012.

Seagrass mapping assessment: Between 2012 and 2014, total seagrass cover for the Sarasota Bay region increased by 702 acres or 5.6%, from 12,587 acres to 13,289 acres (Table 1). In 2014, most of the seagrass acreage in the region occurred in the Sarasota bay subregion (Figure 1), which includes Palma Sola Bay (11,614 acres, or 87%). Seagrass expansion in the Sarasota Bay subregion also accounted for 90% of the increase from 2012 through 2014. Seagrass acreage increased by small amounts in Roberts Bay, Little Sarasota Bay and Blackburn from 2012 through 2014.

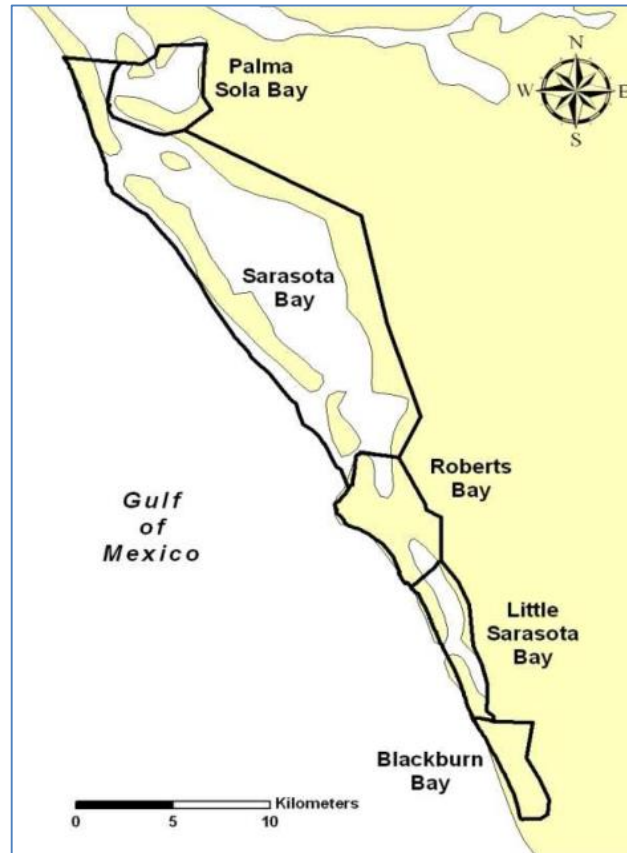
Figure 2 Estuary segments of Sarasota Bay used in seagrass and water quality data analyses.

- Continue development of the Sarasota Bay optical model, and use this model to evaluate water quality and light attenuation as part of the SBEP Comprehensive Conservation and Management Plan. For more accurate assessment and management, bay waters are divided into segments having generally homogeneous water quality and seagrass conditions. Sarasota Bay is divided into several subestuaries, including Palma Sola Bay, Sarasota Bay, Roberts Bay, Little Sarasota Bay, and Blackburn Bay (Figure 2).
