Bishop Creek Stream Assessment

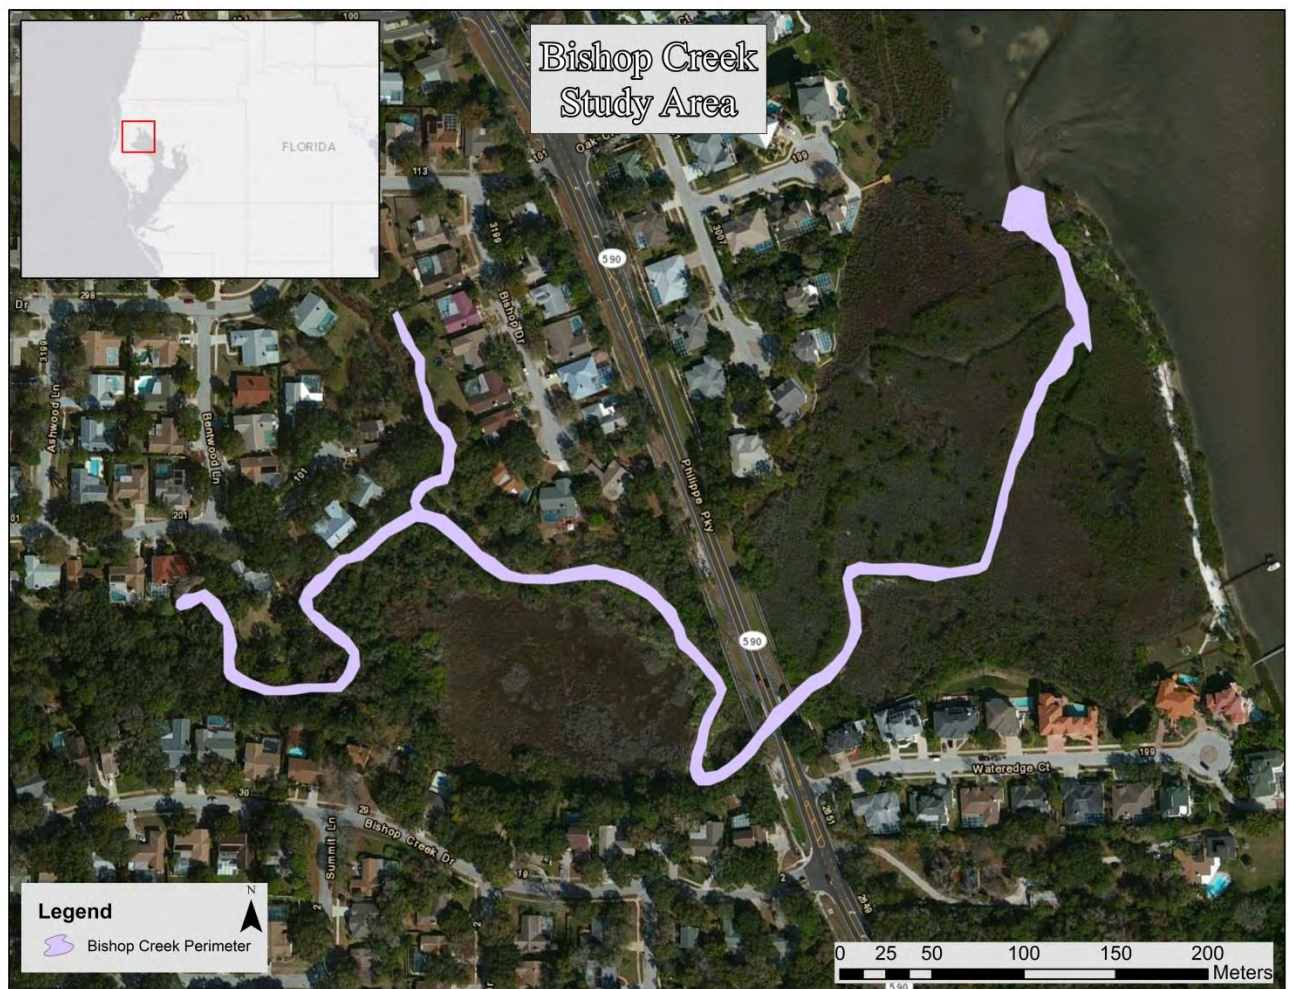
Figure 6. Bishop Creek Study Area

Bishop Creek is located in northern Pinellas County where it flows into Old Tampa Bay. Bishop Creek's watershed is highly urbanized having a watershed LDI value of 7.0 and is comprised of residential and commercial land uses. The creek is split into two upstream branches both of which flow through residential areas with some vegetation along the creek. The upstream portion of the creek has been altered and has steep ditch like banks. The lower portion of Bishop Creek, after the two branches converge, becomes more natural before it flows into Old Tampa Bay. The area immediately adjacent to the creek has a buffer LDI value of 5.6.

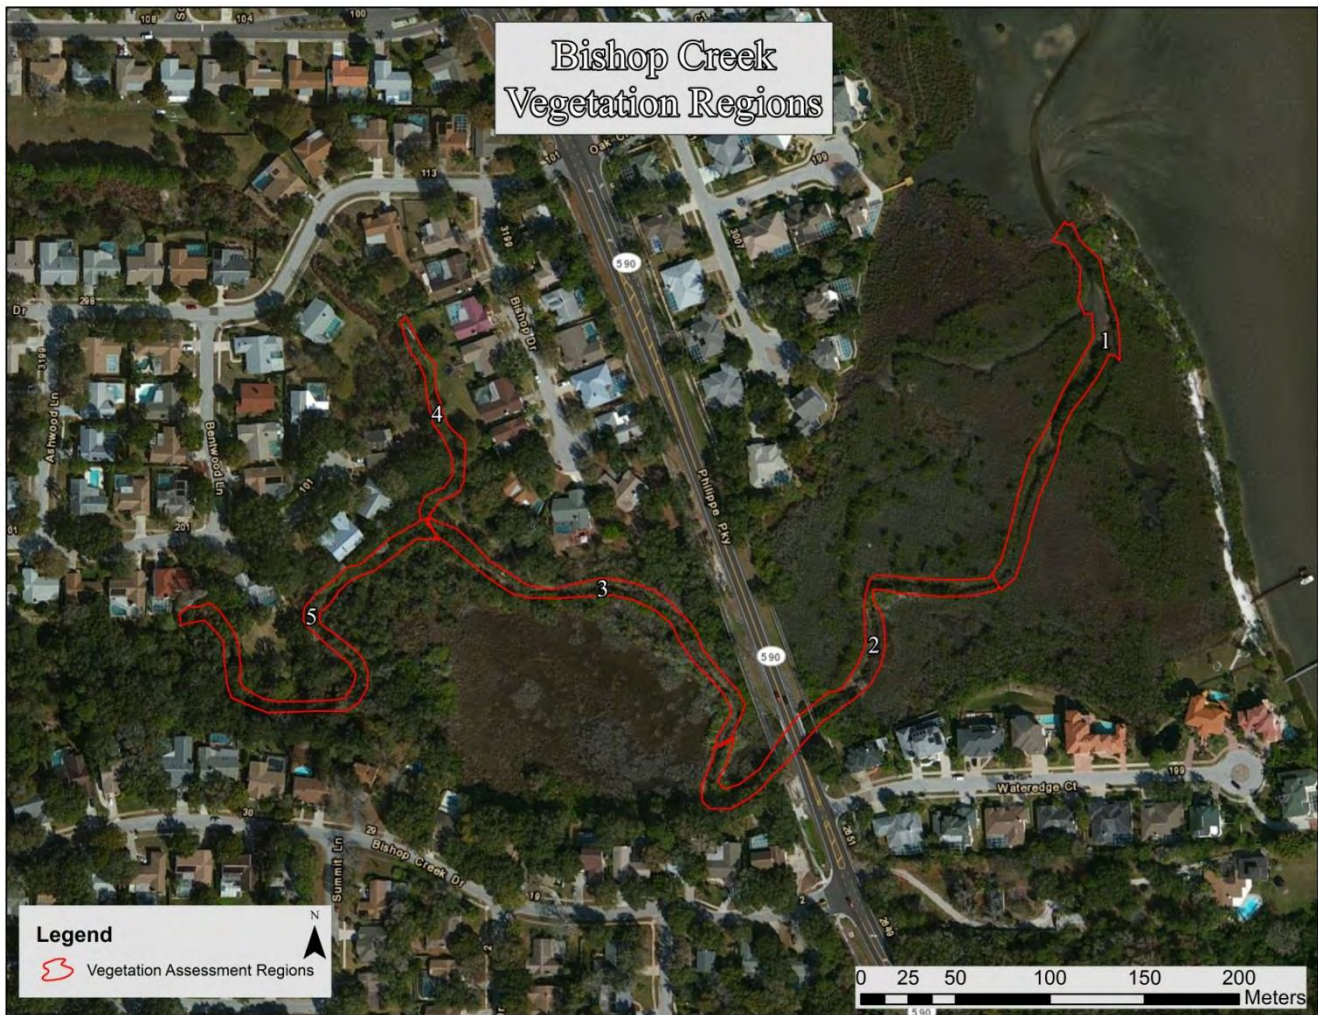
Figure 7. Overview of Bishop Creek Vegetation Assessment Regions

The Bishop Creek vegetation assessment encompassed 5 vegetation regions from the mouth in Old Tampa Bay to upstream from Philippe Parkway as shown in Figure 7. In these regions, 65 species of vegetation were identified. Region 1 and Region 2 were dominated by mangroves (*Rhizophora mangle*, *Laguncularia racemosa* and *Avicennia germinans*) with few other salt tolerant species present. The most upstream mangrove was *Rhizophora mangle* in Region 5. The first occurrence of Leather Fern (*Acrostichum danaeifolium*) was in Region 2. Needle Rush (*Juncus roemerianus*) was first observed in Region 1 with the last occurrence in Region 3. Above Region 3 the vegetation communities are populated by many species indicative of dominating freshwater influence.

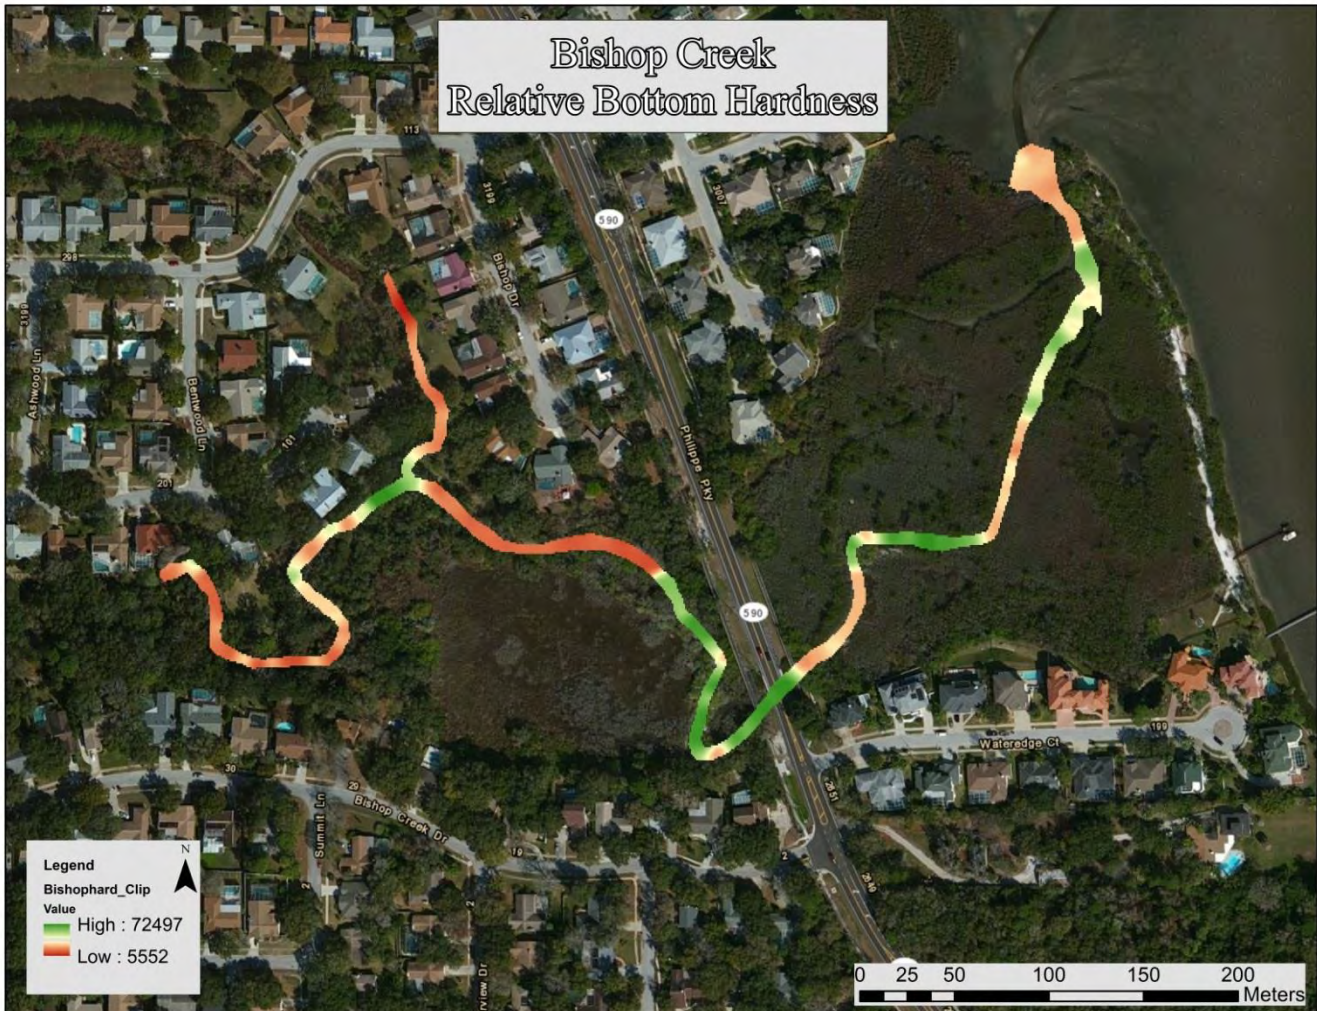
Figure 9. Bishop Creek Relative Bottom Hardness Map

Collected sonar data was processed through Dr. Depth software to analyze the strength of the return signal from the bottom to get an estimate of the relative bottom hardness for Bishop Creek. Figure 9 shows the bottom hardness raster for Bishop Creek. This map is meant to help identify locations of harder and softer bottoms for benthic invertebrate sampling, fish sampling and benthic chlorophyll sampling. The higher the hardness value, the harder the bottom substrate.

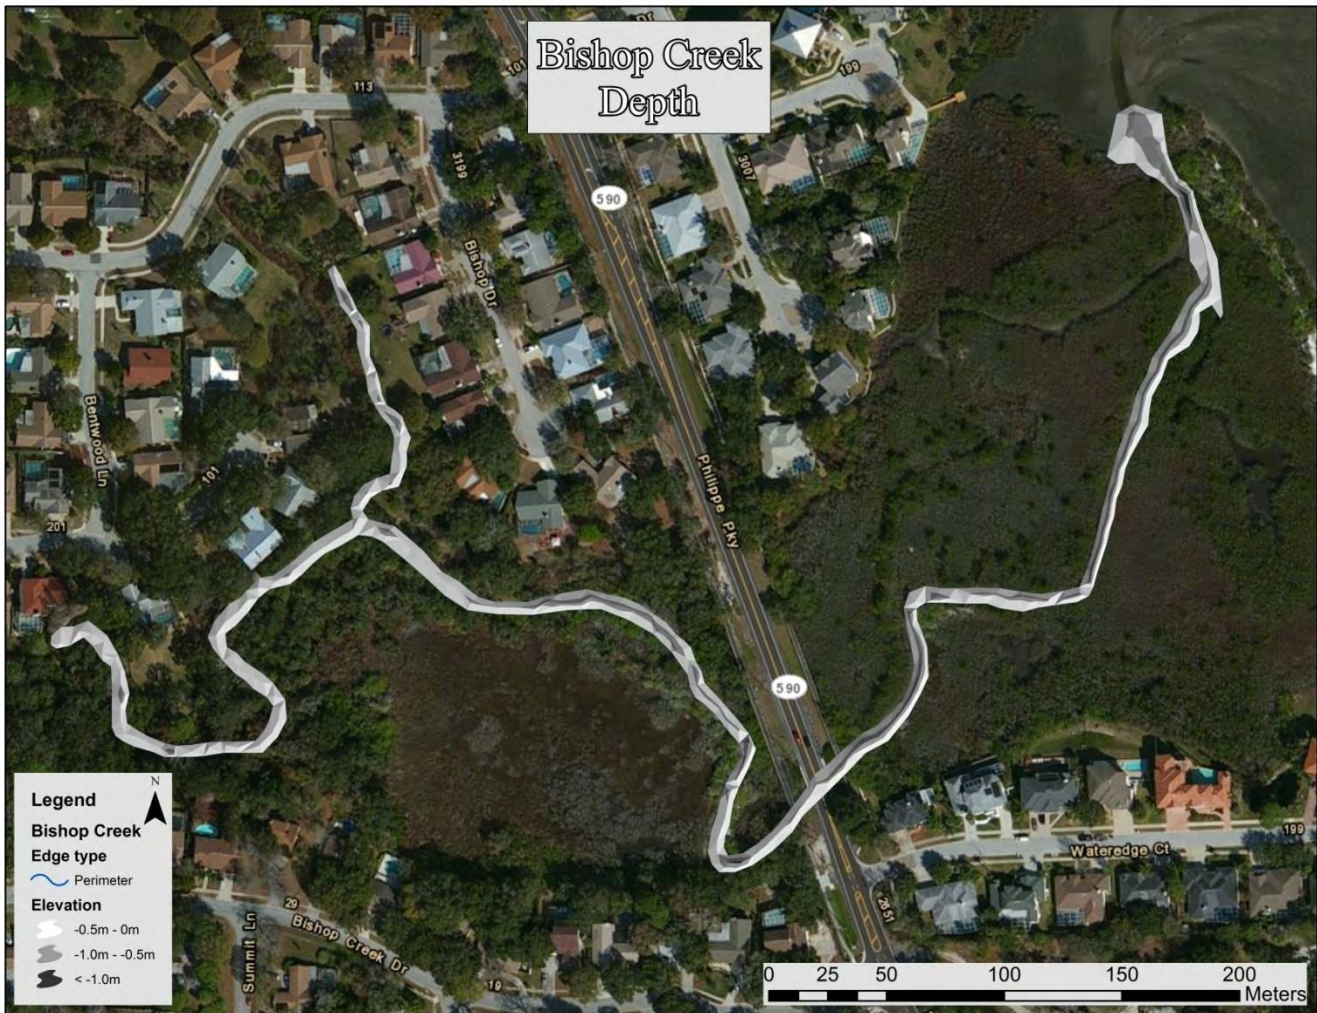
Figure 10. Bishop Creek Bathymetric Stratum Map

In the study area, Bishop Creek had a mean depth of 1.94 feet and a maximum depth of 4.16 feet. A total of 0.19 acres of creek was mapped during the assessment. At the time of assessment, Bishop Creek contained an estimated 597,298 gallons of water in the study area. Figure 10 details the bathymetric mapping for Bishop Creek showing the three depth stratum.
