# Buck Creek Stream Assessment

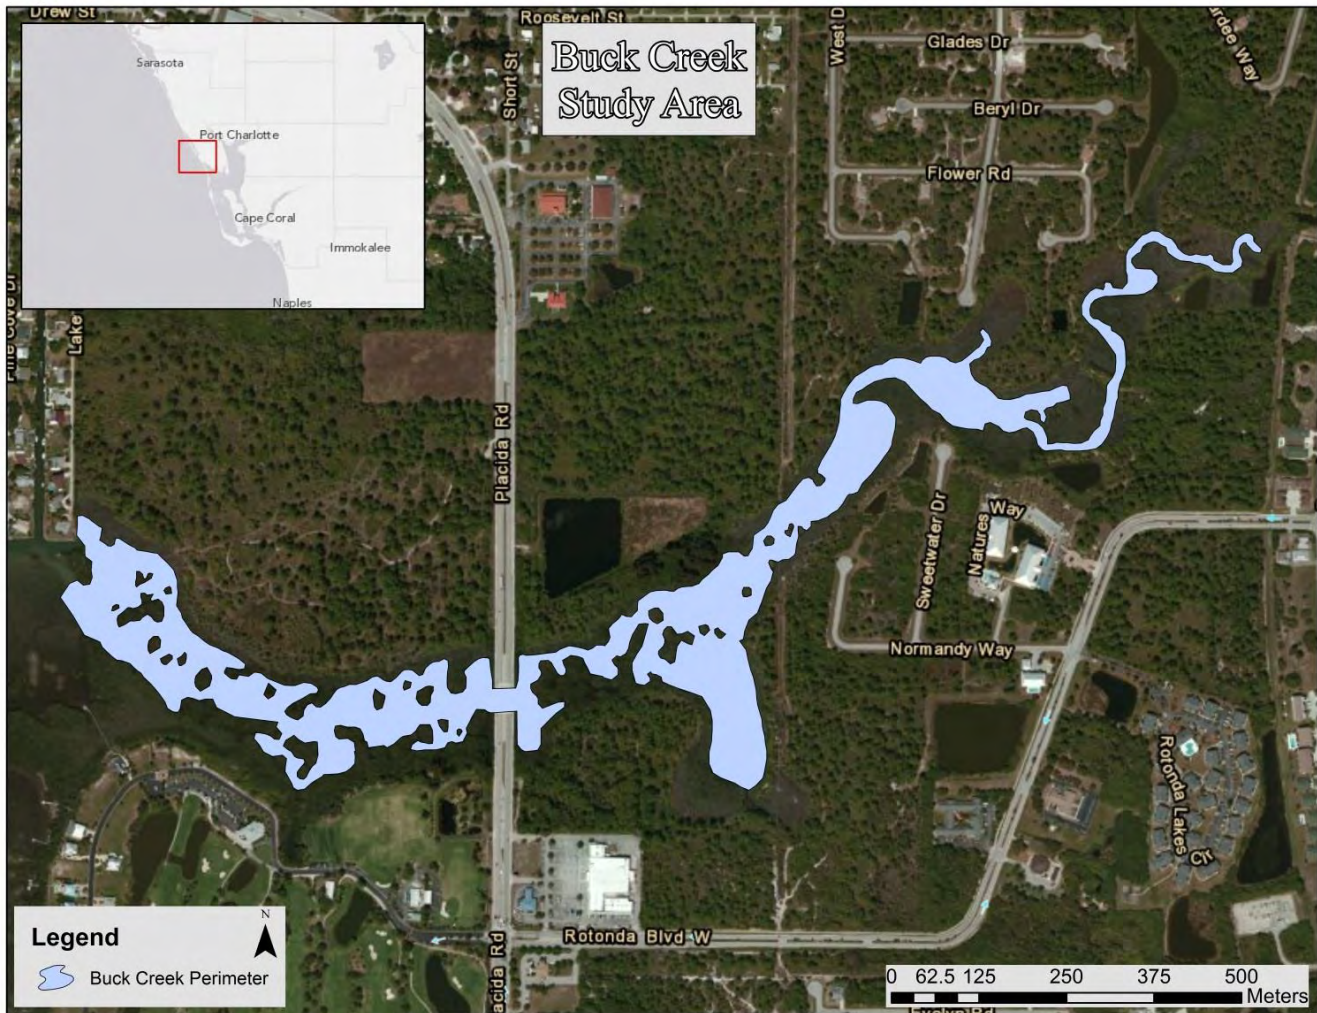
Figure 57. Overview of the Buck Creek Study Area

Buck Creek is located in a relatively unimpaired watershed. Most of the creek is bordered by mangroves. A small area of medium density residential property borders a portion of the downstream area of Buck Creek. A golf course that is buffered by mangroves is located within the downstream portion of the creek. Buck Creek’s watershed has a LDI value of 3.8 and the area immediately surrounding the creek with a buffer LDI value of 1.2.

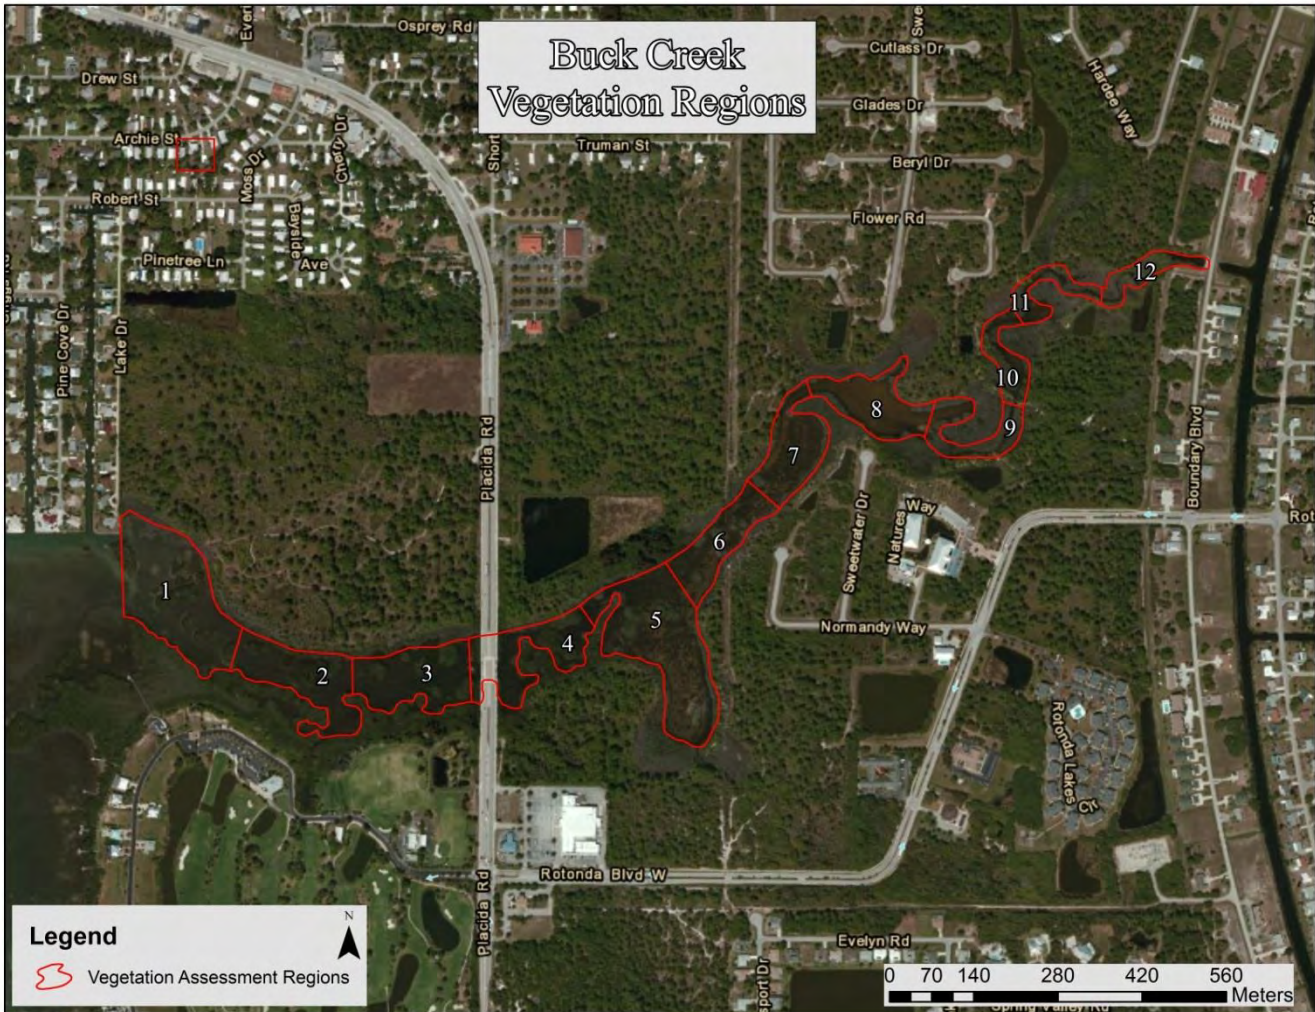
Figure 58. Overview of Buck Creek Vegetation Assessment Region

The Buck Creek vegetation assessment encompassed 12 vegetation regions from the mouth in Lemon Bay to the Boundary Road crossing as shown in Figure 58. In these regions, 21 species of vegetation were identified. Regions 1 through 12 were dominated by mangroves (*Rhizophora mangle* and *Laguncularia racemosa*) with few other salt tolerant species present. The first occurrence of Leather Fern (*Acrostichum danaeifolium*) was in Region 11. Needle Rush (*Juncus roemerianus*) was first observed in Region 7, becoming dominant in Regions 11 and 12. Buck Creek showed a vegetation community influenced by salinity and tides throughout the study area.

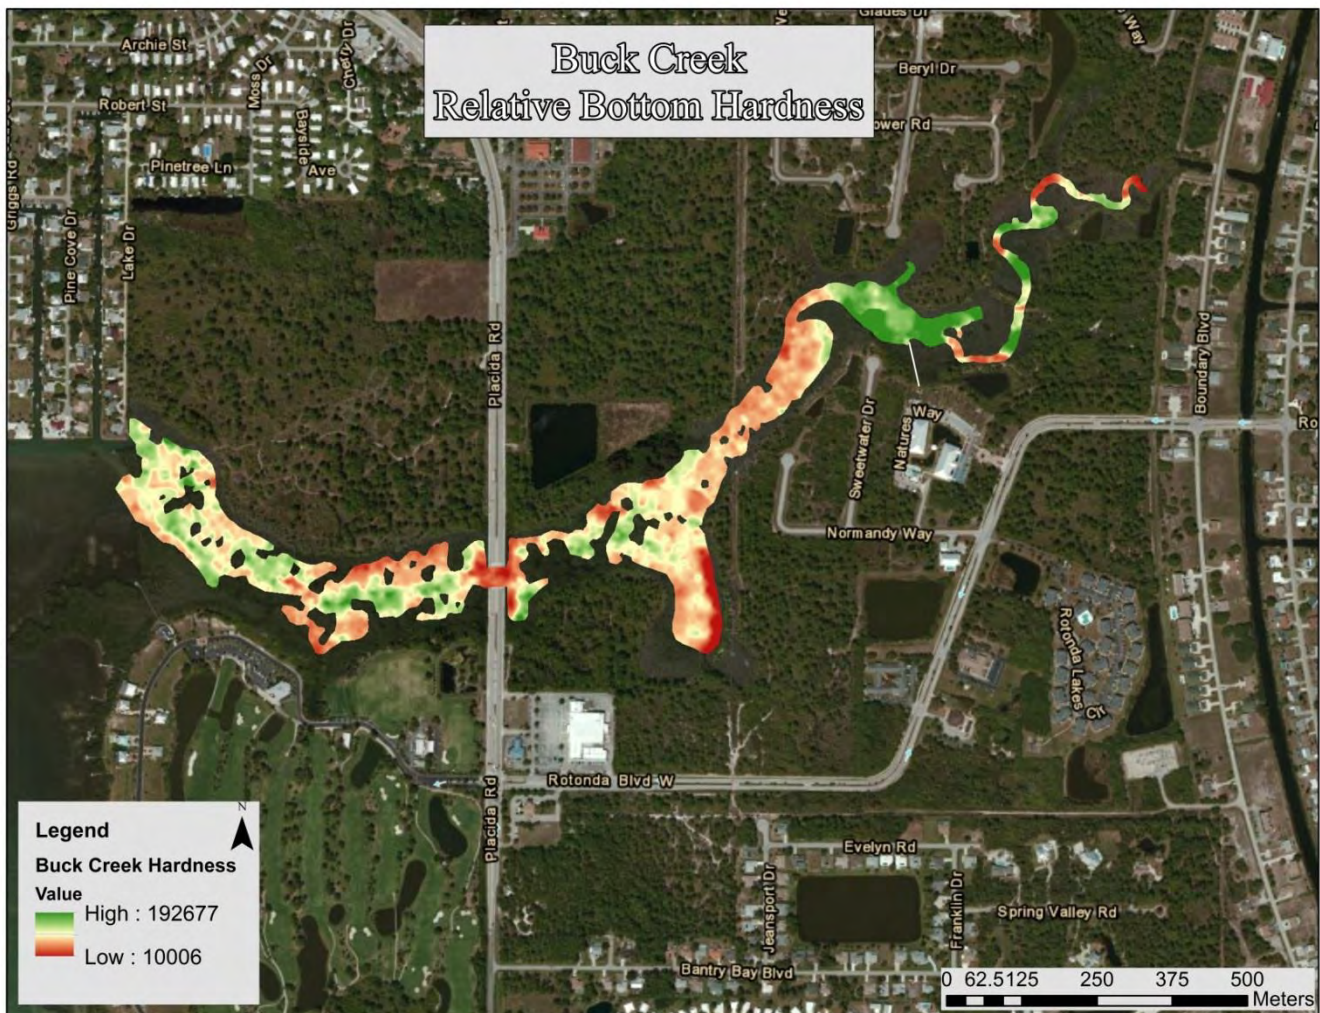
Figure 60. Buck Creek Relative Bottom Hardness Map

Collected sonar data was processed through Dr. Depth software to analyze the strength of the return signal from the bottom to get an estimate of the relative bottom hardness for Buck Creek. Figure 60 shows the bottom hardness raster for Buck Creek. In this raster, the higher the hardness value, the harder the bottom substrate. This map is meant to help identify locations of harder and softer bottoms for benthic invertebrate sampling, fish sampling and benthic chlorophyll sampling.

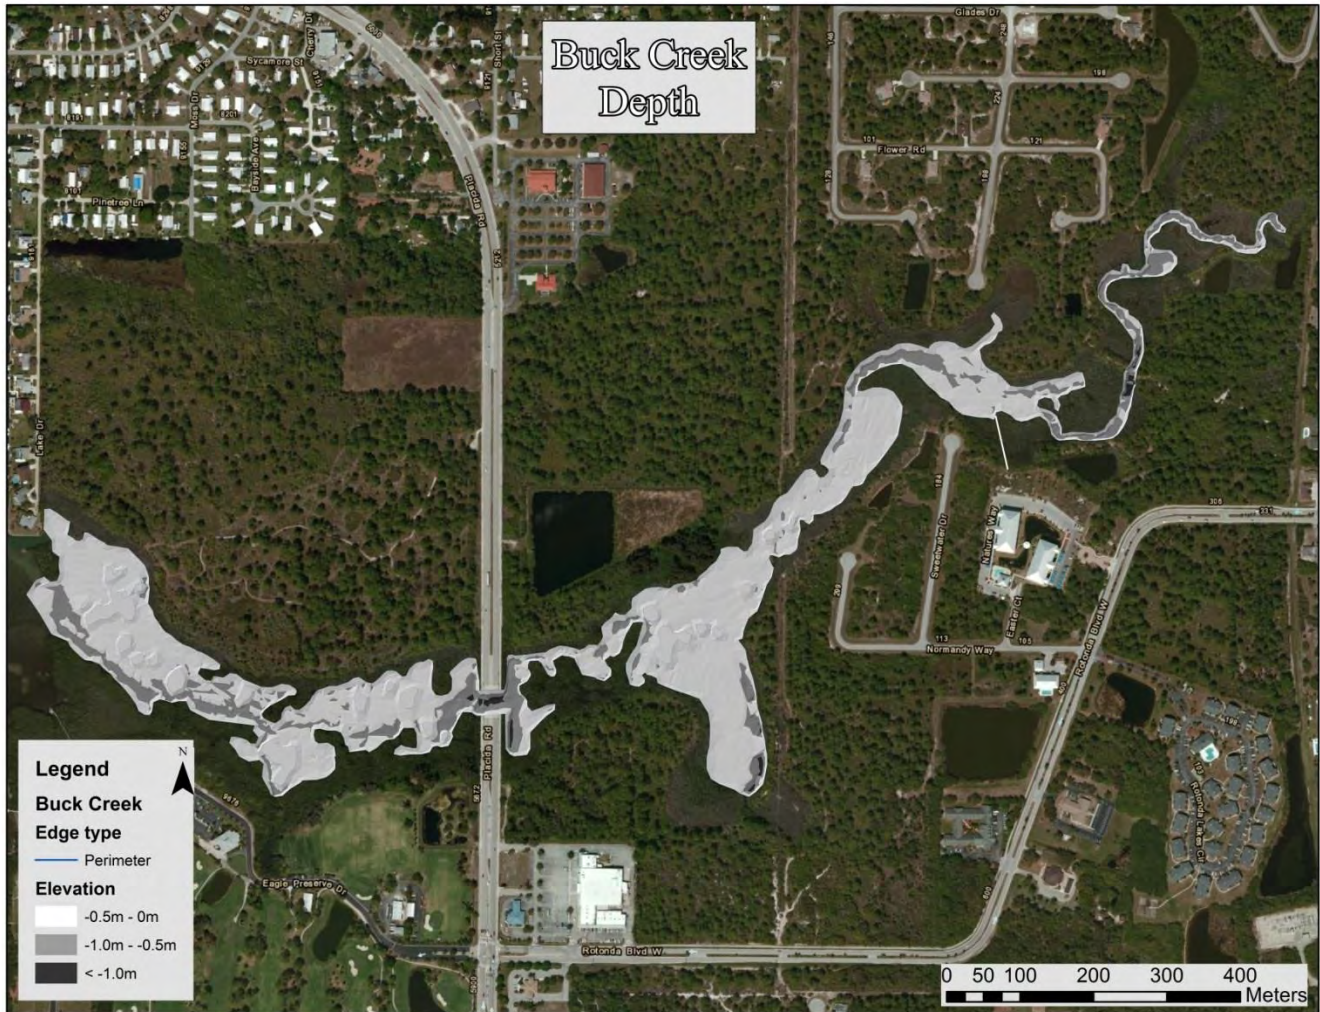
Figure 61. Buck Creek Bathymetric Stratum Map

In the study area, Buck Creek had a mean depth of 1.73 feet and a maximum depth of 5.35 feet. A total of 36.94 acres of creek was mapped during the assessment. At the time of assessment, Buck Creek contained an estimated 14,652,632 gallons of water in the study area. Figure 61 details the bathymetric mapping for Buck Creek showing the three depth stratum.
