# Estero River Stream Assessment

## Study Area

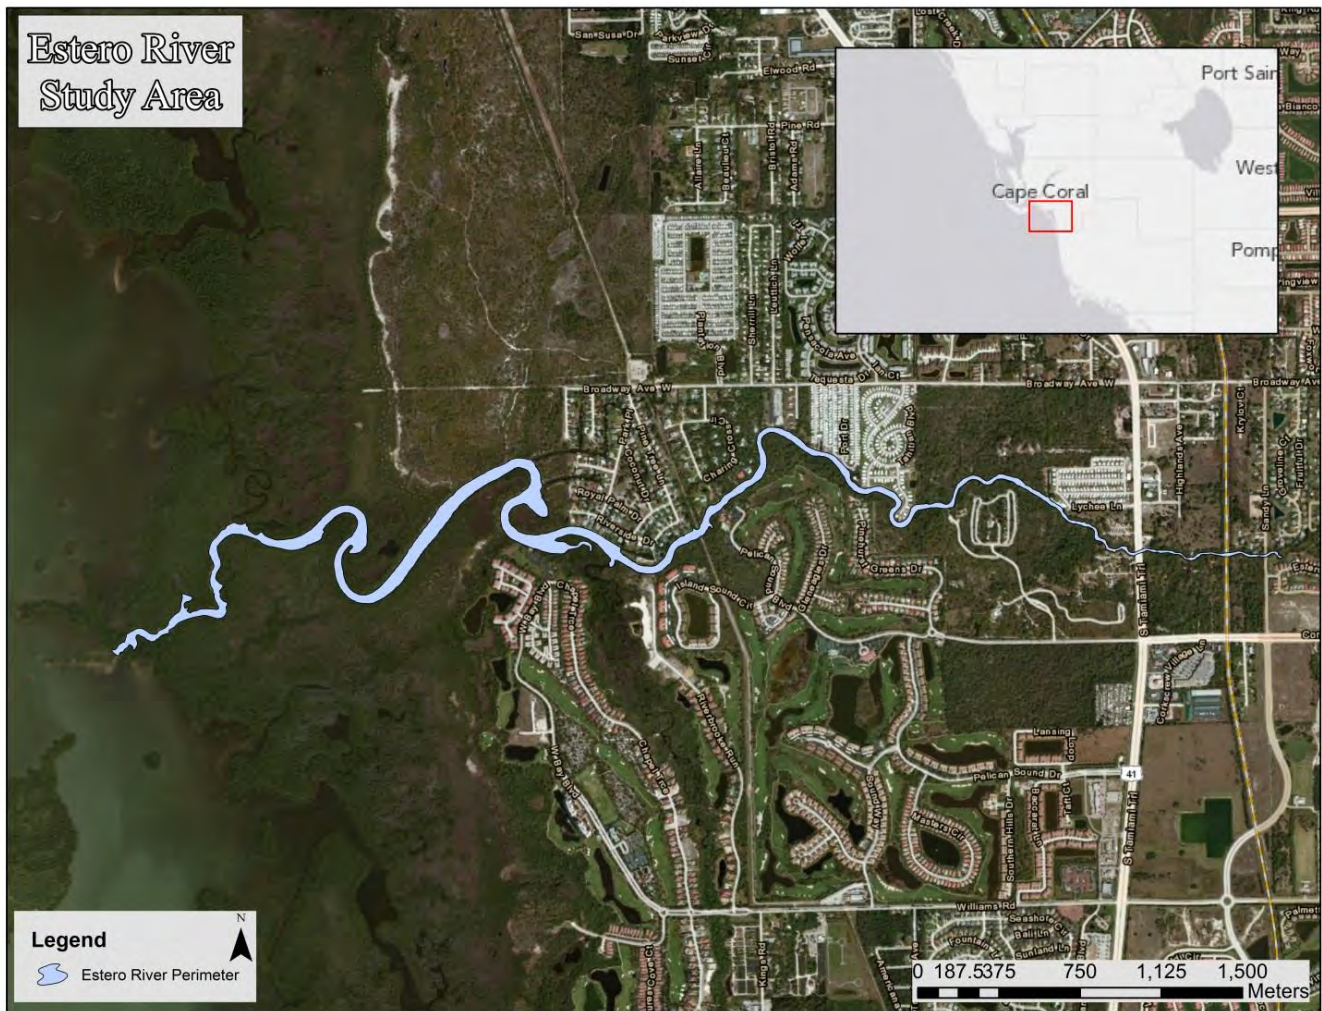
Figure 89. Overview of the Estero River Study Area

Estero River is located in the middle of Estero Bay in Lee County. This system is surrounded by golf courses and residential areas but appears to be relatively hydrologically unaltered. To the west of US41 on the southern bank of the Estero River is Koreshan State Park which provides a natural undeveloped habitat in a relatively developed stream. Where Halfway Creek flows into the Estero River the system becomes surrounded by mangrove swamps and marshes until it reaches Estero Bay. This system’s watershed has a LDI value of 4.1 and the area adjacent to the creek has a buffer LDI value of 3.4.

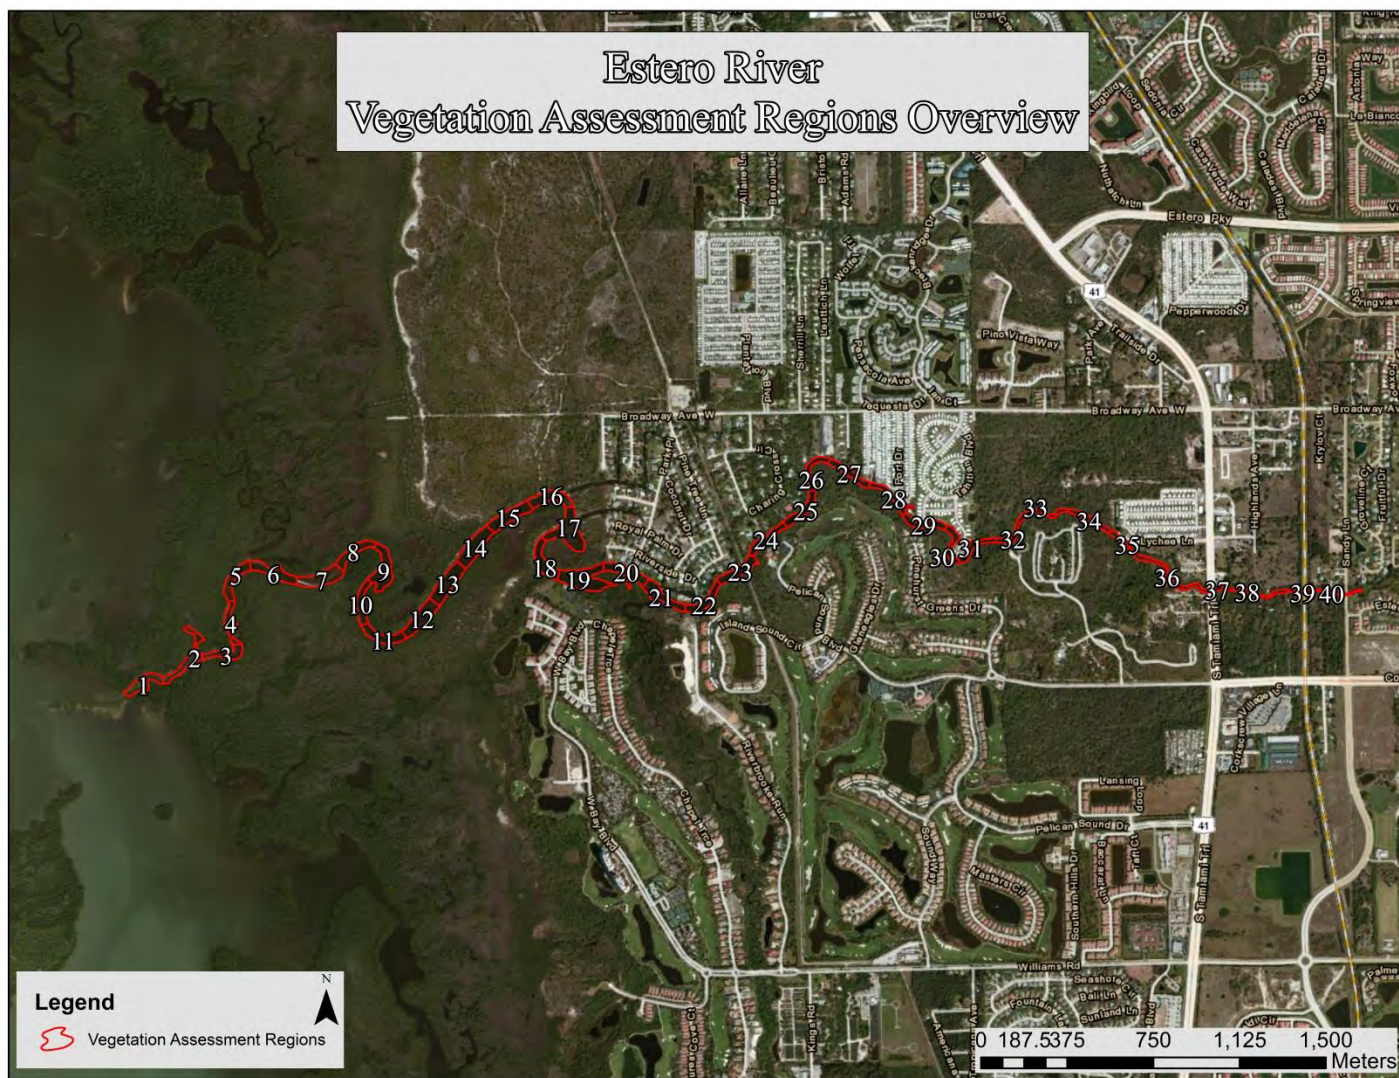
Figure 90. Overview of Estero River Vegetation Assessment Regions

The Estero River vegetation assessment encompassed 40 vegetation regions from the mouth in Estero Bay to above Sandy Lane as shown in Figure 90 through Figure 92. In these regions, 66 species of vegetation were identified. Regions 1 through 27 were dominated by mangroves (*Rhizophora mangle*, *Laguncularia racemosa* and *Avicennia germinans*) with few other salt tolerant species present. Mangroves were present throughout the study area. The first occurrence of Leather Fern (*Acrostichum danaeifolium*) was in Region 15. Needle Rush (*Juncus roemerianus*) was first observed in Region 16 with the last occurrence in Region 30. Above Region 38 the vegetation communities are populated by many species indicative of dominating freshwater influence.

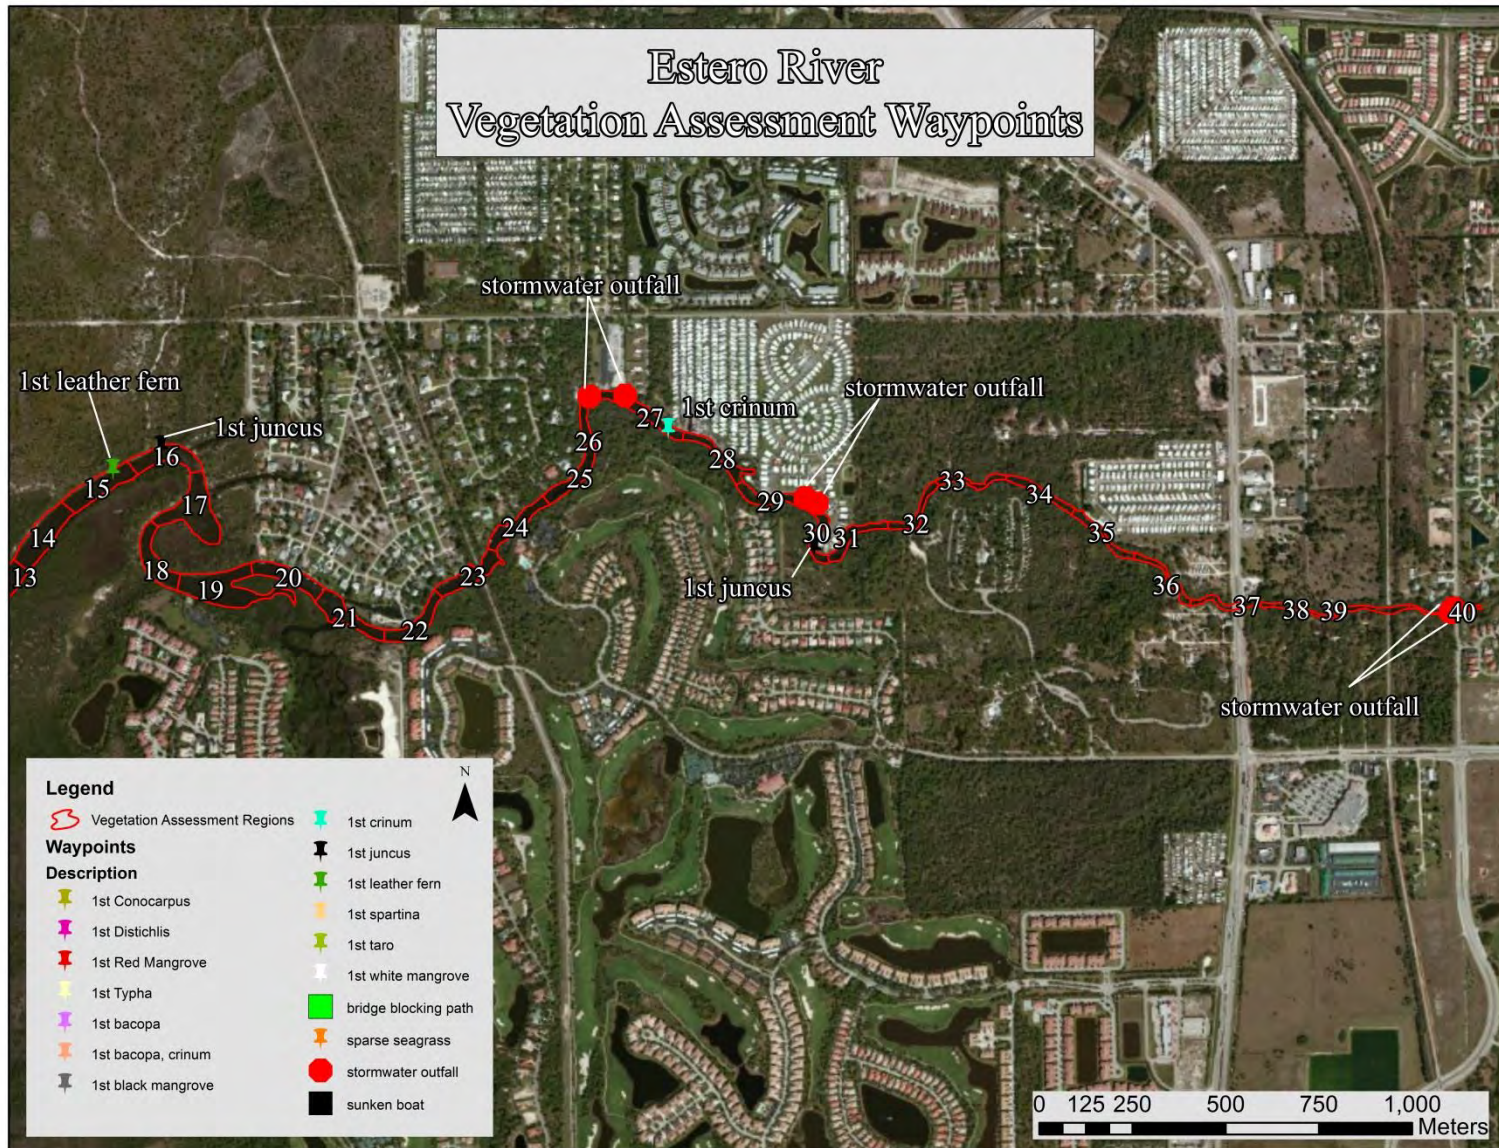
Figure 93. Estero River Vegetation Waypoints

Figure 93 shows the vegetation transition zones of Estero River indicating the most upstream *Juncus* as well as the most downstream Leather Fern, *Juncus* and *Crinum*. Based on the vegetation assessment data for Estero River, regions 1 through 15 would comprise the highest salinity and tidal influence zone, regions 16 through 30 would comprise the “mixing” zone and regions 30 through 40 would comprise the freshwater dominant zone. The vegetation assessment species lists are shown in Table 21 through Table 22.

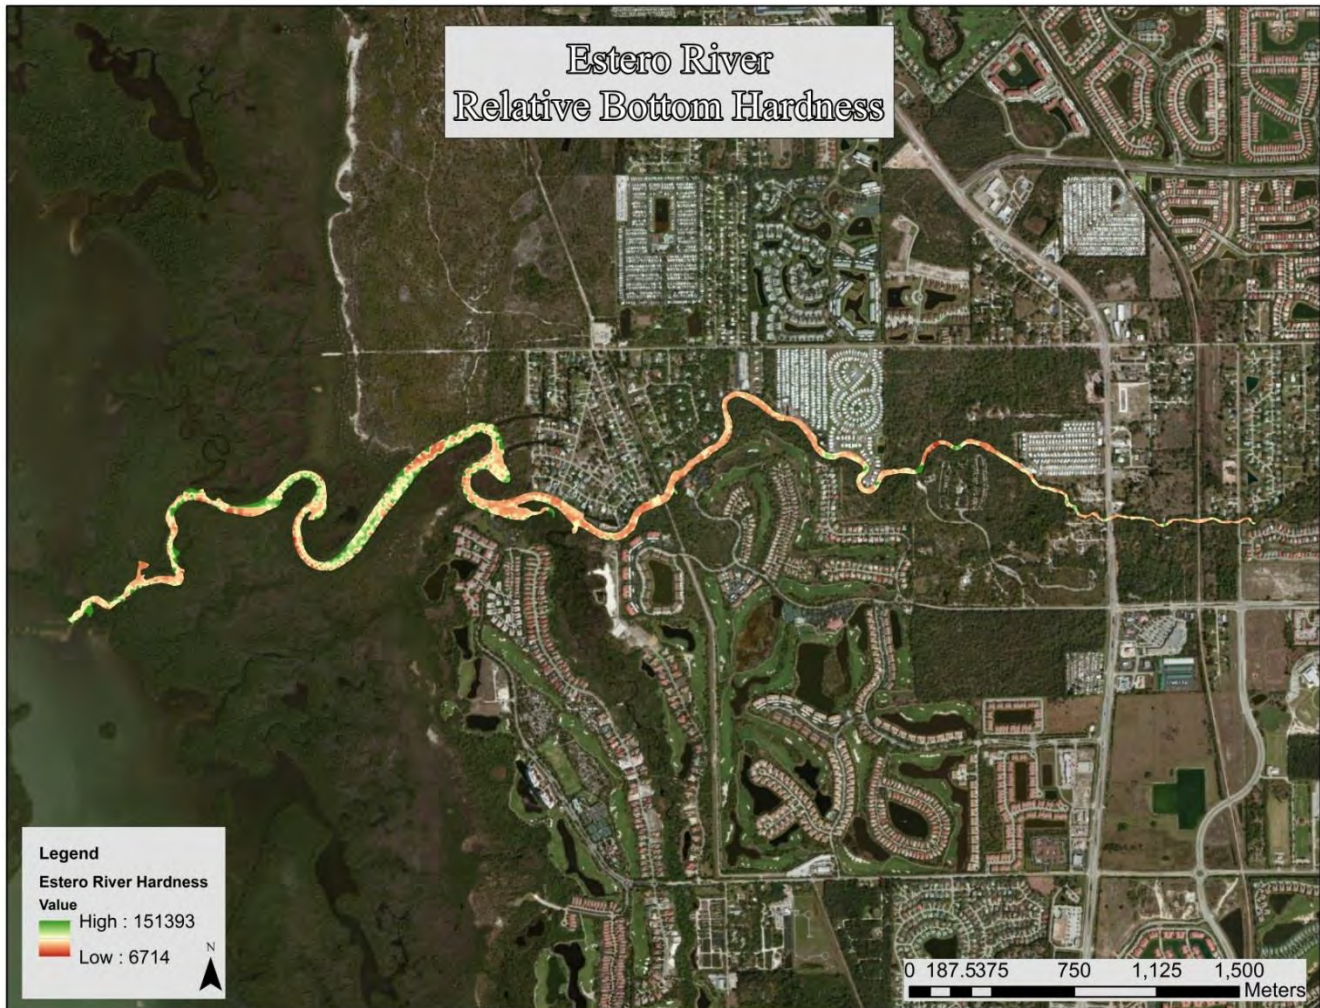
Figure 94. Estero River Relative Bottom Hardness Map

Collected sonar data was processed through Dr. Depth software to analyze the strength of the return signal from the bottom to get an estimate of the relative bottom hardness for Estero River. Figure 94 shows the bottom hardness raster for Estero River. In this raster, the higher the hardness value, the harder the bottom substrate. This map is meant to help identify locations of harder and softer bottoms for benthic invertebrate sampling, fish sampling and benthic chlorophyll sampling.

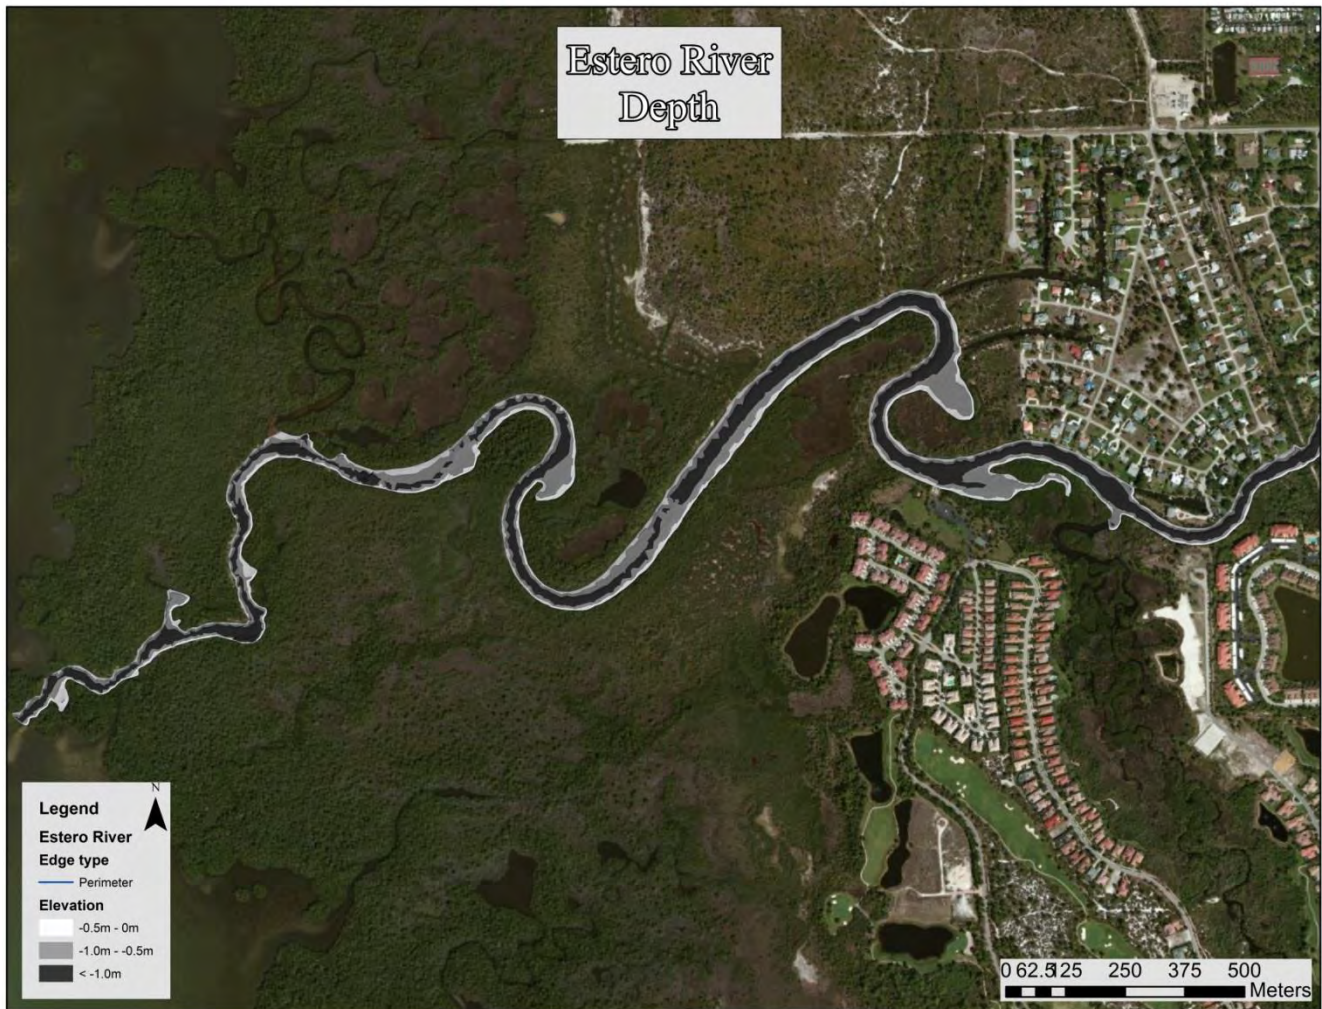
Figure 95. Estero River Bathymetric Stratum Map (1 of 2)

In the study area, Estero River had a mean depth of 3.99 feet and a maximum depth of 12.06 feet. A total of 73.78 acres of creek was mapped during the assessment. At the time of assessment, Estero River contained an estimated 69,288,066 gallons of water in the study area. Figure 95 and Figure 96 detail the bathymetric mapping for Estero River showing the three depth stratum.
