Mapping the Characteristics and Condition of the Charlotte Harbor Coastal Shoreline using Volunteer Boater Observations and Photointerpretation

**Charlotte Harbor National Estuary Program
Technical Report 07-4
November 15, 2007**

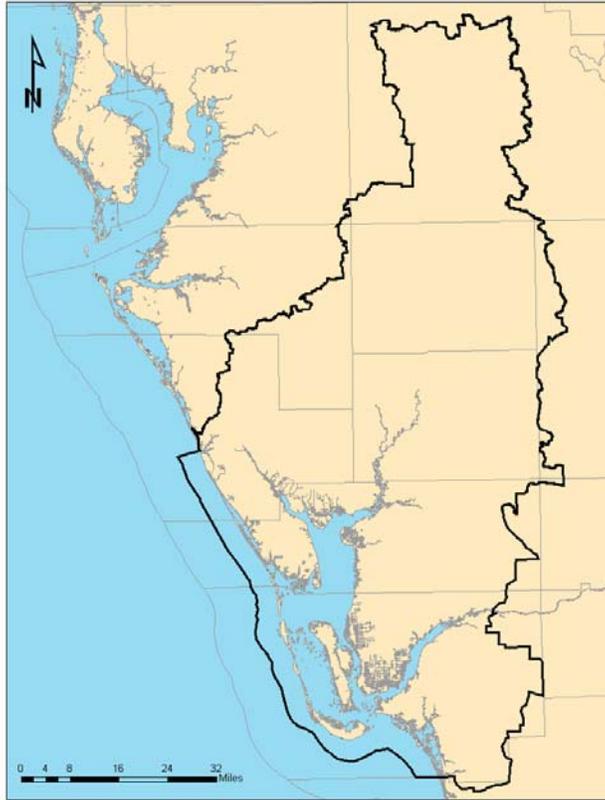
Figure 1. The Charlotte Harbor National Estuary Program study area includes coastal regions in Sarasota, Charlotte and Lee Counties.

The goal of this project was to develop a shoreline condition map, for the coastal areas within the CHNEP boundary (Figure 1), that could be used as a tool for decision makers, scientists and resource users. The additional objectives that are related to this goal are:

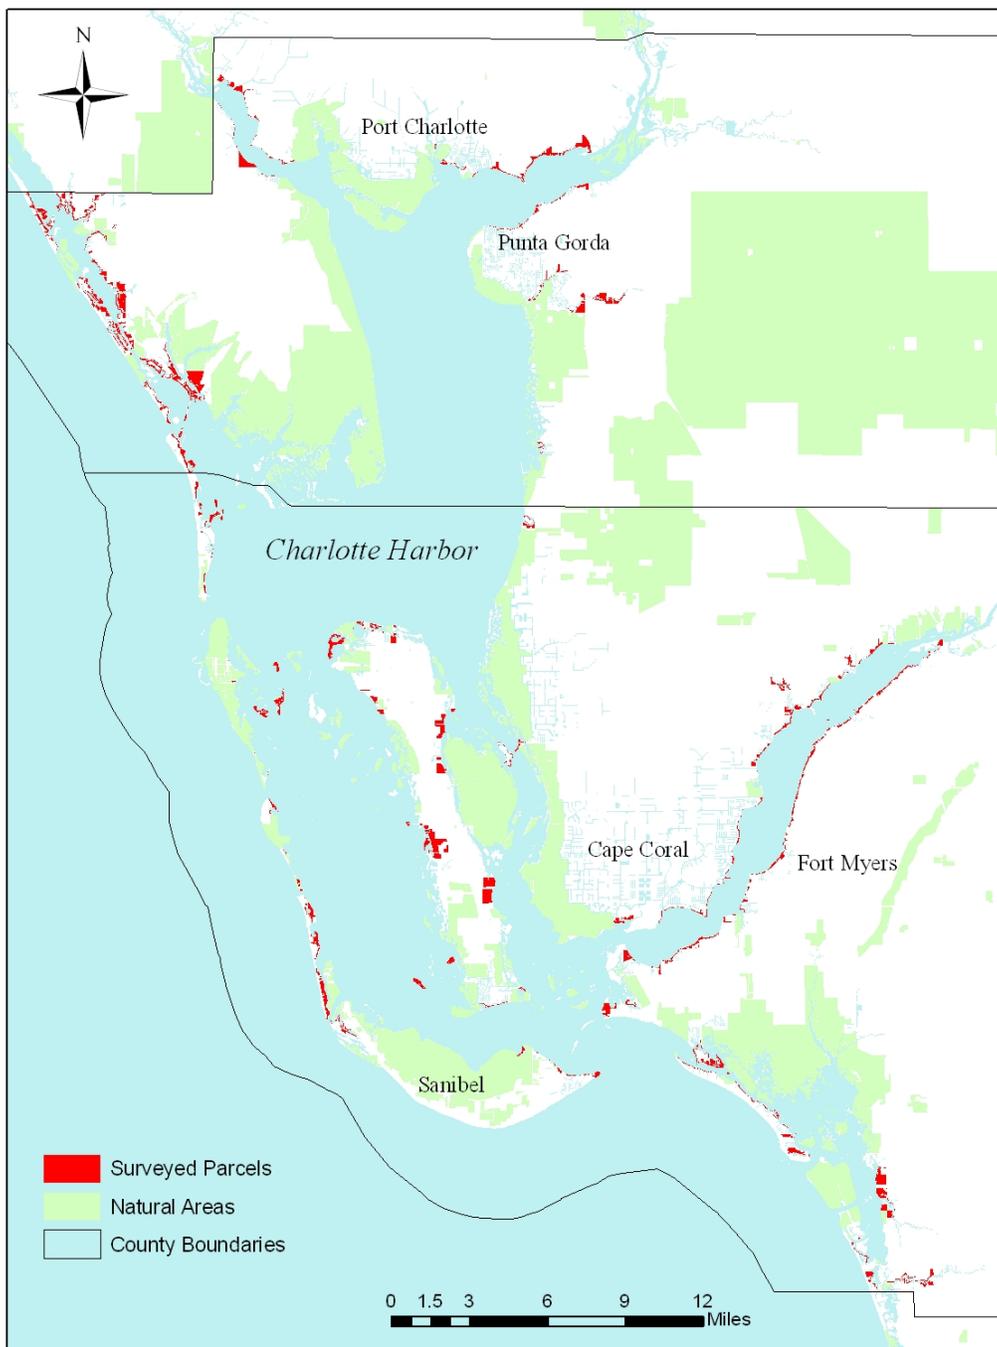
Figure 2. Areas within Charlotte (north) and Lee Counties (south) surveyed by volunteer boaters.

The developed areas surveyed (Figure 2) included those parcels along the open water or tributaries to the estuary, and did not include canals. The following areas were included:

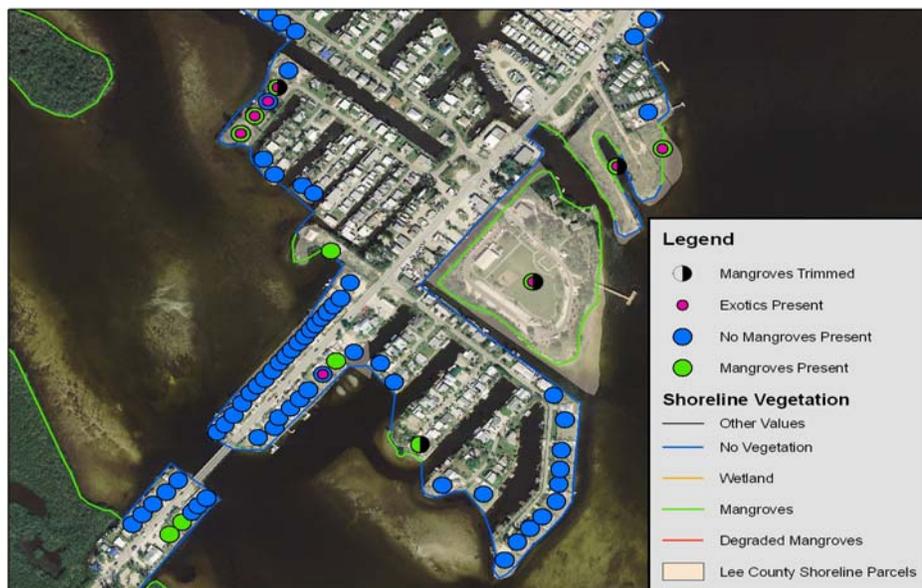
Figure 3. Volunteer observations around Matlacha demonstrates an area with little remaining mangrove shoreline and some exotic vegetation.

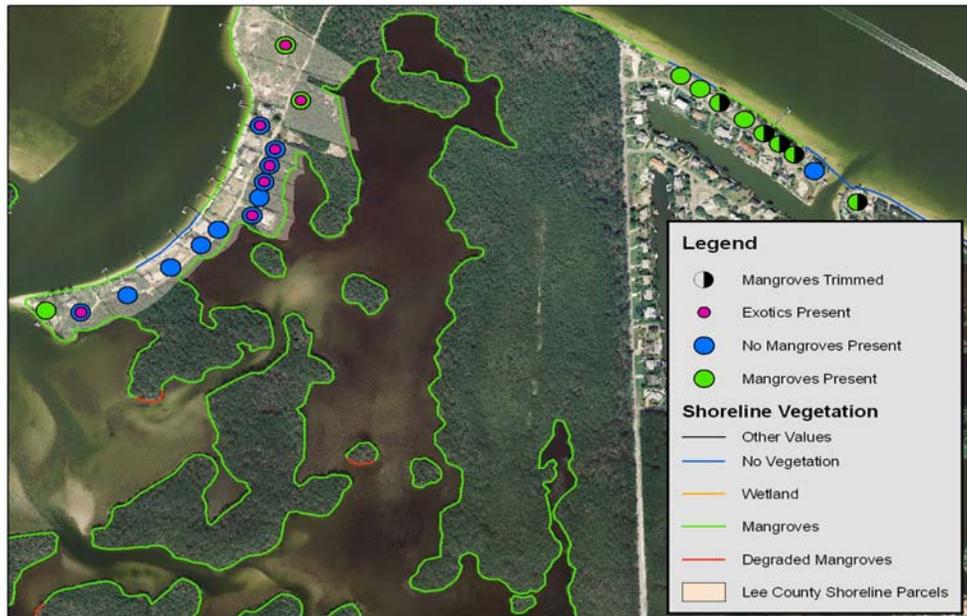
Figure 4. Volunteer observations from the eastern side of Sanibel Island show a mixture of shoreline types, including exotic vegetation, no vegetation, mangrove, and trimmed mangroves.

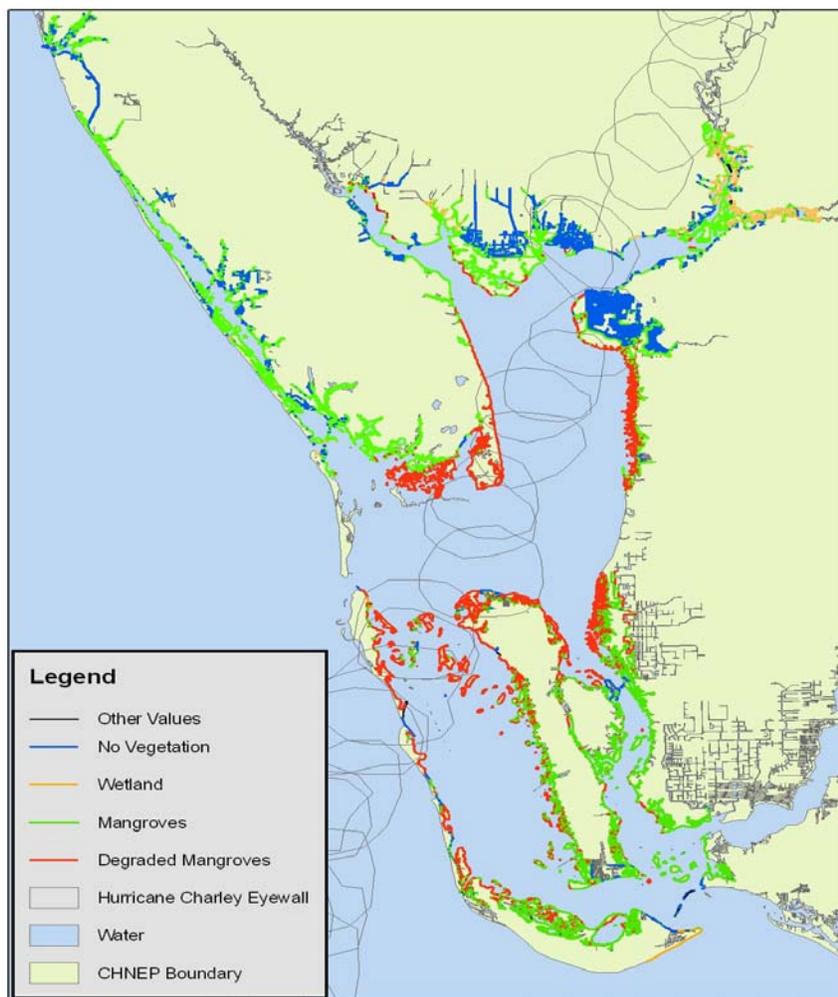
Figure 5. Preliminary shoreline photointerpretation shows those areas where mangroves are degraded in relation to the path of Hurricane Charley.

The photointerpretation is not completed at this time; however 1698 miles have been classified. This data is **very** preliminary as the ground-truthing and accuracy assessments are not complete. This preliminary assessment shows 73% of the mapped shoreline (1232 miles) consists of mangroves. Of the mangrove shoreline 34% (419 miles) are degraded. There are 397 miles of seawall (23%) and only 24 miles of rip rap (1.4%).
