# Trabue Harborwalk Oyster Reef Restoration Three Year Post Installation Results

Report Prepared by Laura Geselbracht, Senior Marine Scientist, The Nature Conservancy (TNC)  
February 2019

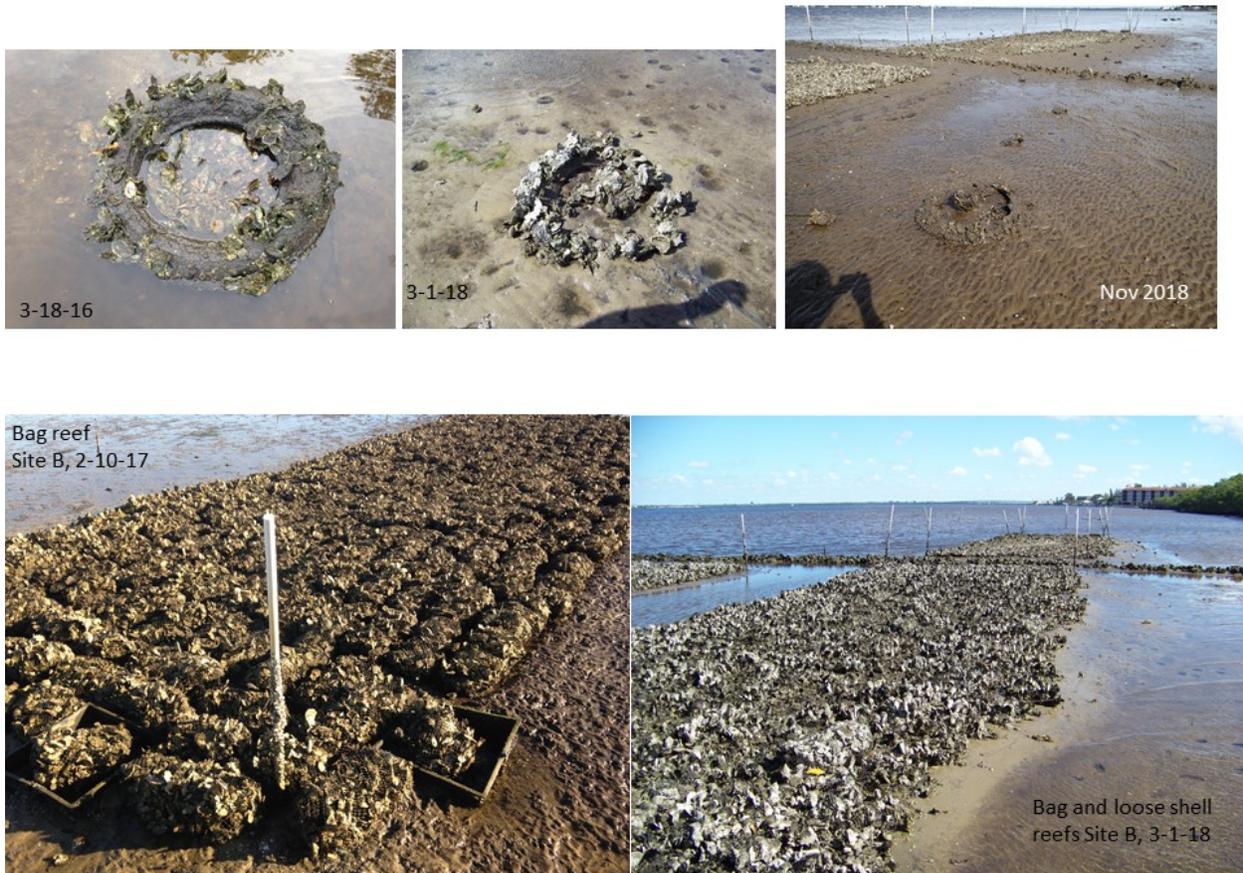
Between Years 1 and 2, The mat and bagged shell reefs increased in height and the loose shell reefs experienced a slight decrease in height (Table 1, Figure 1). This slight average decrease in height could be explained by a modest amount of shell that was pushed off the reef to the immediately adjacent area following Hurricane Irma. The reduction in height is small however (1 cm) and could also be explained by sampling variability. In general, the trend in reef height was positive. During the Year 3 sampling, a sizeable decrease in reef height (the distance between the sediments immediately adjacent to the reef and the lengthwise center point of the reef) was measured for all three reef types. This appears to have been caused by accelerated sedimentation of the reefs during Hurricane Irma in September of 2017. Sediments finer than those previously present around the reefs moved into the area and reef materials appeared buried as compared to previous years. An abandoned tire that has been present near the reefs since before deployment illustrates this phenomenon (Figure 2). Although some sedimentation was observed from the time of the deployment through March of 2017, sedimentation following the storm was more pronounced.

**Figure 2. Photos of tire and bagged shell reef at Site B showing sedimentation over time. Sedimentation following Hurricane Irma (Sept 2017) notably increased.**

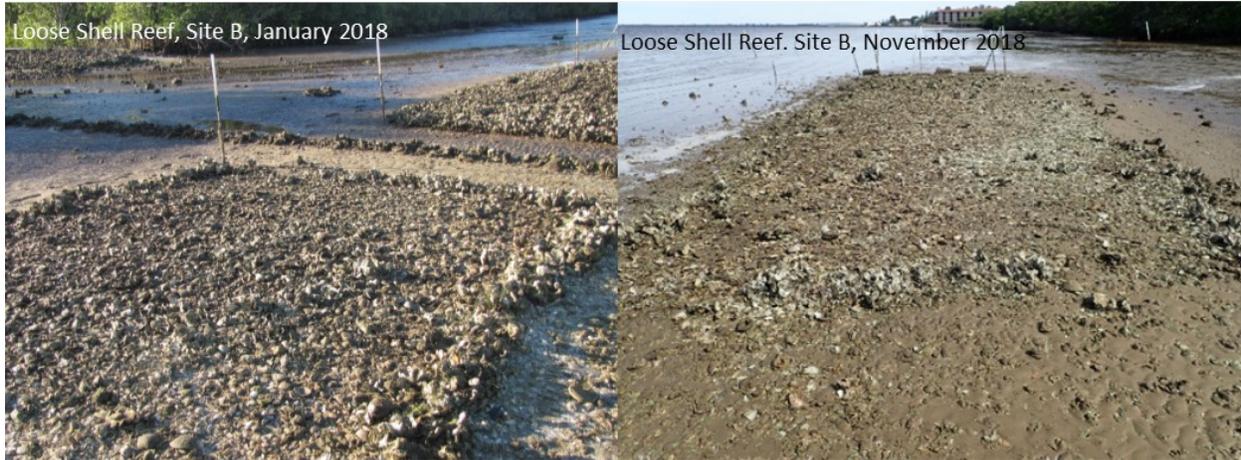
Areal extent of the reefs has not changed except on the loose shell reefs where some of the shell has been moved off onto adjacent sediments within approximately 0.5 meters of the original reef footprint (Figure 3).

**Figure 3. Loose shell reefs at Site B, January 2018 and November 2018.**
