Yucca Pen Creek Stream Assessment

Study Area

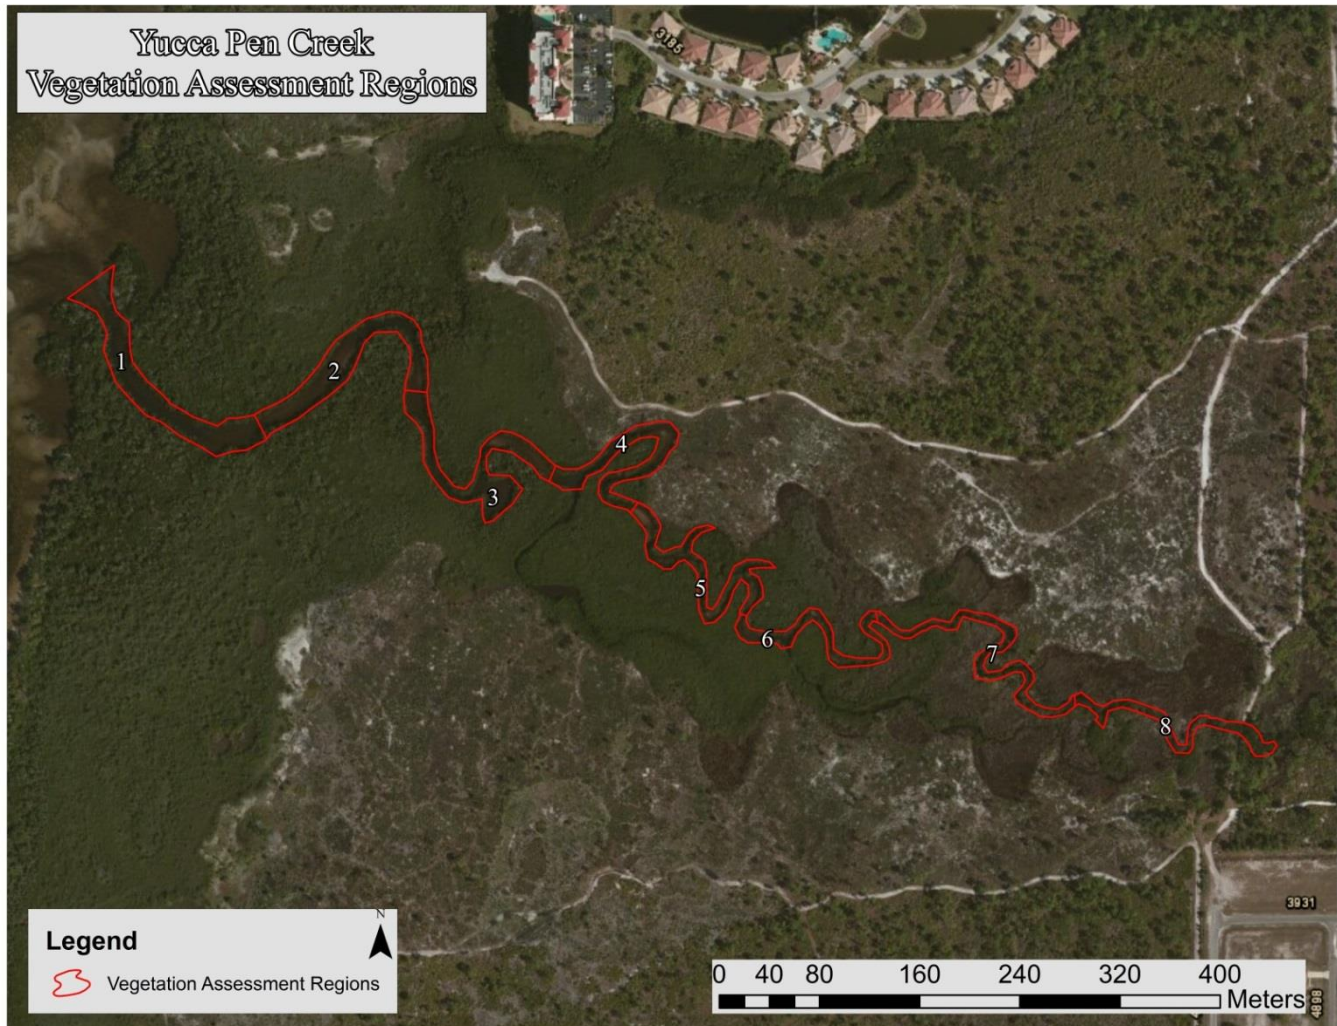
The Yucca Pen Creek vegetation assessment encompassed 8 vegetation regions from the mouth in Charlotte Harbor to Old Burnt Store Road as shown in Figure 85. In these regions, 20 species of vegetation were identified. Regions 1 through 8 were dominated by mangroves (*Rhizophora mangle*, *Laguncularia racemosa* and *Avicennia germinans*) with few other salt tolerant species present. The first occurrence of Leather fern (*Acrostichum danaeifolium*) was in region 6, becoming dominant in region 7. Needle Rush (*Juncus roemerianus*) was first observed in region 4. Throughout the study area they vegetation indicated influence of salinity.

Figure 85. Overview of Yucca Pen Creek Vegetation Assessment Regions

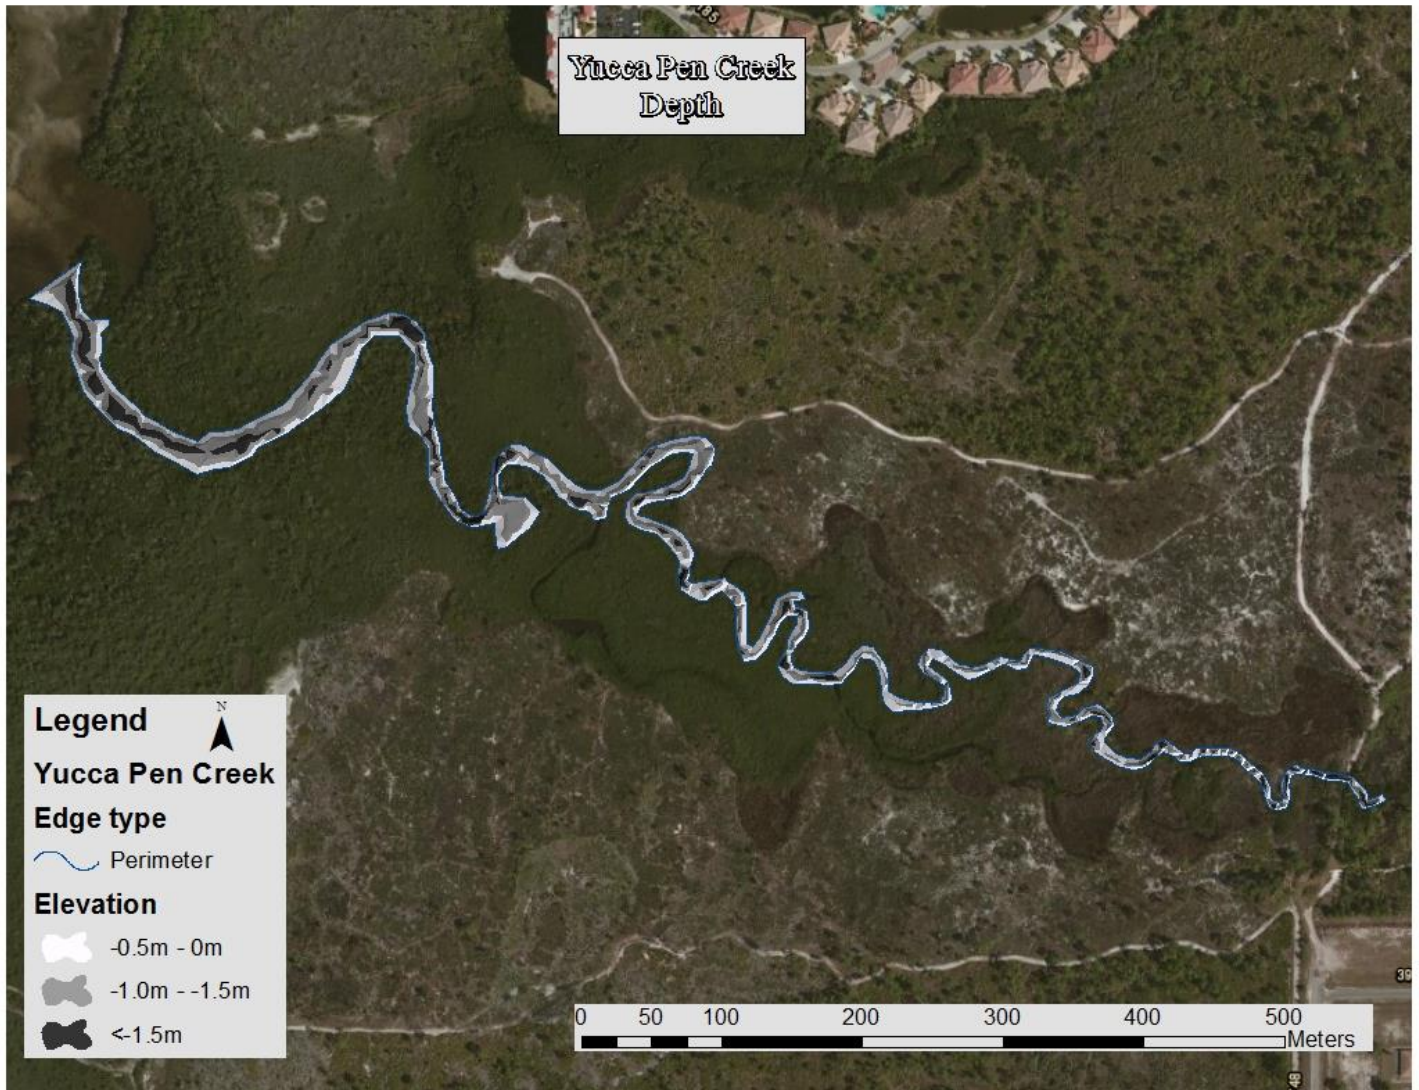
In the study area, Yucca Pen Creek had a mean depth of 3.49 feet and a maximum depth of 12.87 feet. A total of 5.12 acres of creek was mapped during the assessment. At the time of assessment, Yucca Pen Creek contained an estimated 3,051,932 gallons of water in the study area. Figure 88 details the bathymetric mapping for Yucca Pen Creek showing the three depth stratum.

Figure 88. Yucca Pen Creek Bathymetric Stratum Map
